## Situation:

## Solution:

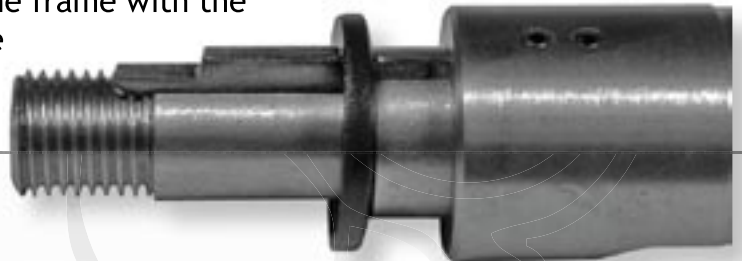
This picture shows the forward end of the barrel assembly. First the barrel seat is slid onto the fore end of the barrel. Then you must rotate the barrel seat until the slot on the barrel seat is aligned with the slot on the barrel. With the slots aligned you must then insert the barrel key through both slots. Next, the barrel assembly is inserted into the frame with the forward threads protruding from the muzzle of the frame. The barrel nut is then threaded onto the barrel from the outside of the frame.

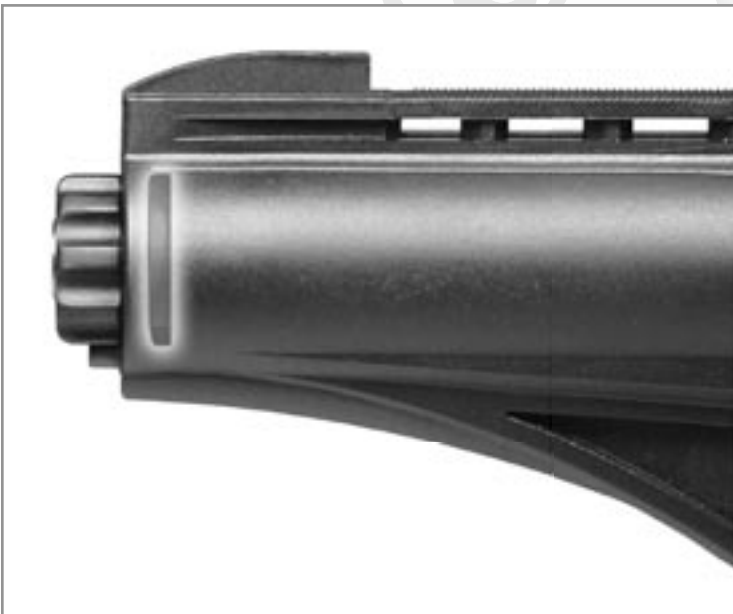
Correct Assembly:

All Whitney Wolverine pistols are inspected, test fired and logged before being shipped. All Whitney Wolverine pistols are correctly assembled, as shown below, when shipped from our facility. If you receive a Whitney Wolverine pistol and it is incorrectly assembled, that is an indication that a dealer or distributor handled the pistol before you received it. The solution to the problem is to reassemble the barrel directed and as shown below.

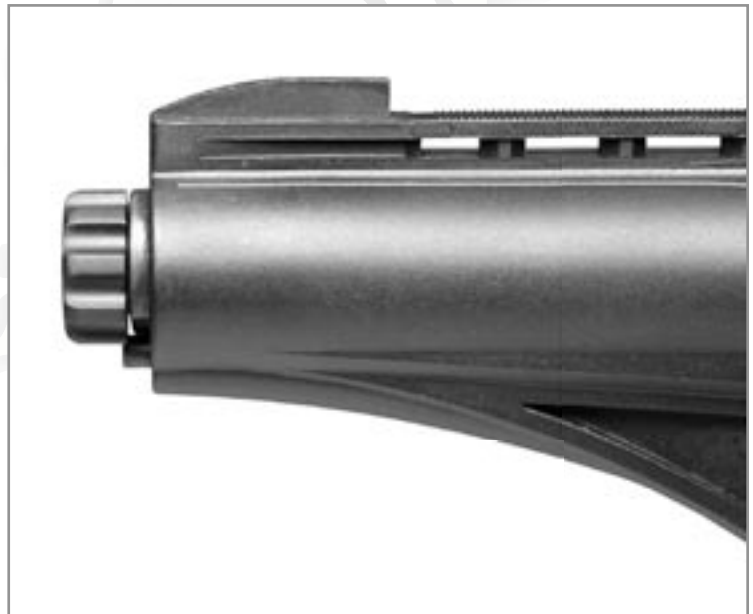
Incorrect Assembly:

The parts view in the Olympic Arms Whitney Wolverine Owner's Manual does not clearly depict how the barrel assembly is arranged. As a result some Whitney Wolverine owners may experience firing issues. The problem stems from the *barrel seat (part 006)* being installed on the outside of the Whitney Wolverine frame. This action offsets the barrel as a component of the barrel assembly. The offset is great enough that the hammer will not strike a round in the chamber.
